Colorado Department
of Public Health
and Environment

Cotter Corporation – Canon City Mill
0502 Fremont County Road 68
P.O. Box 1750
Canon City, CO 81215-1750

SUBJECT: **Notice of Violation**

Prepared by: JJ Reviewed by: _____ Reviewed by: _____ Reviewed by: _____ Mailed by: _____ file
Date: _____ Date: _____ Date: _____ Date: _____ Date Mailed: _____ License
369-01 File 5.2 "Notice of Violation for September 13-17, 2004 inspection"

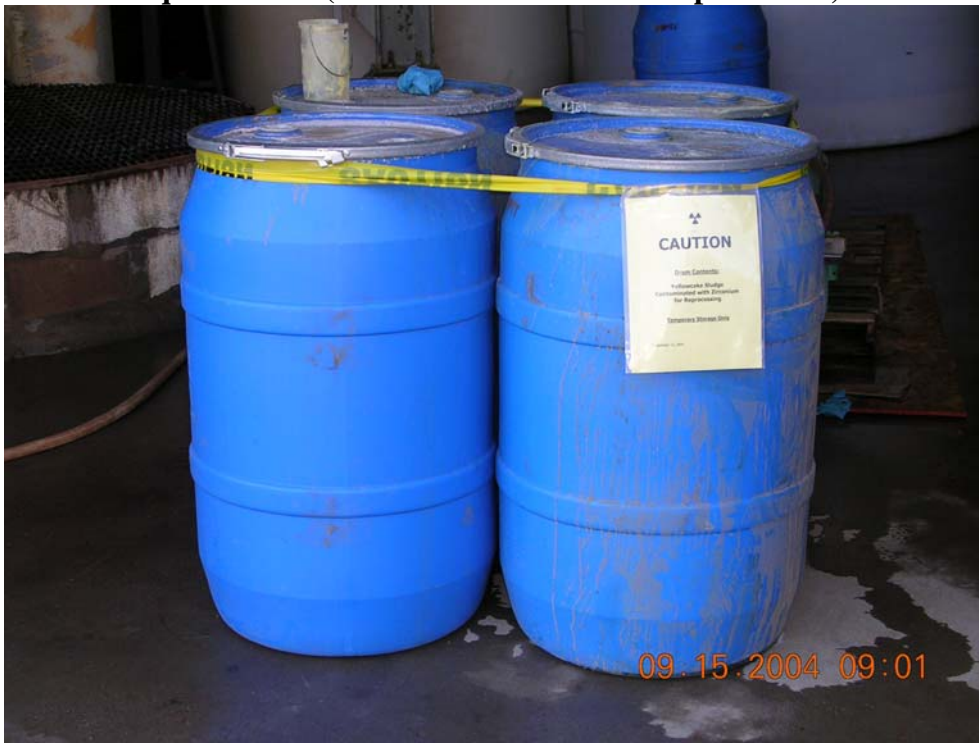
1. RH 4.28.4 and RH 4.30 of the Regulations require specific radiological postings to be used to identify radiological hazards. Contrary to this at the time of the inspection, it was noted that 4 drums containing radioactive material located at the north end of Vanadium/U processing building were posted with signage indicating the words “caution”, the trefoil (radiation) symbol, “drum contents” and date (Refer to Image 1.1 and Image 1.2 of Attachment 1). This posting information is not consistent with the regulations. Containers of radioactive materials require posting as “Caution – Radioactive Material” in accordance with RH 4.30.

This violation is a Severity Level IV and each type of this violation would have an associated civil penalty of \$625.

Image 1.1 Photograph of 4 drums containing radioactive material not posted in accordance with RH 4.30 requirements. (Refer to Item of Non-Compliance #1).

The licensee should review all radiological postings to ensure that all postings used for radiological hazards are consistent with the requirements of RH 4.28 and RH 4.30.

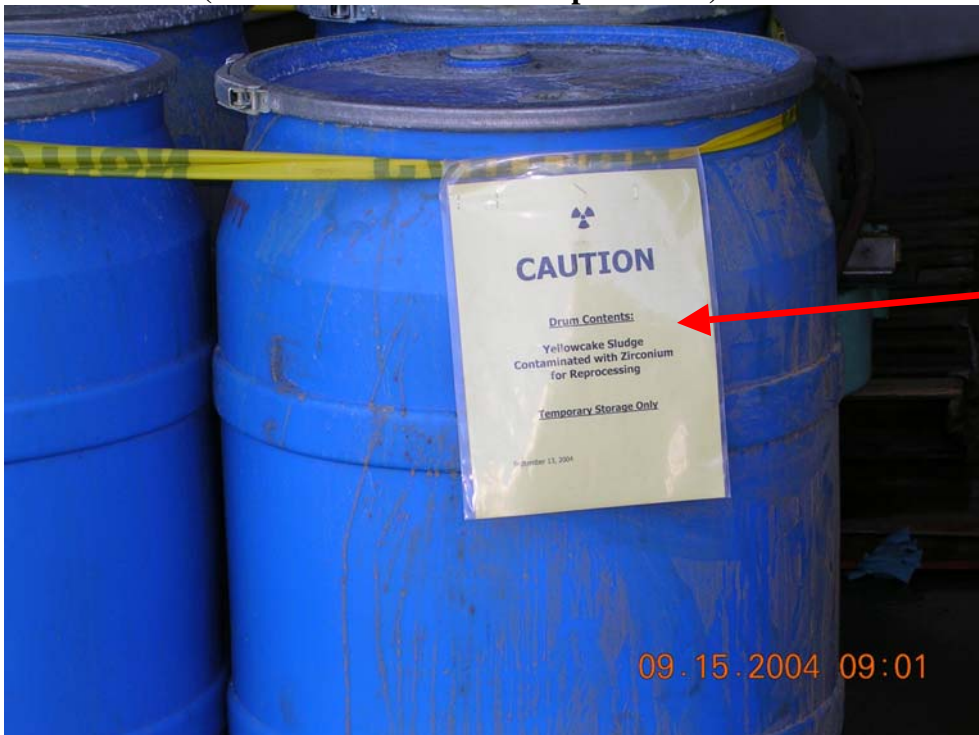
Image 1.2 Close-up photograph of drum containing radioactive material not posted in accordance with RH 4.30. (Refer to Item of Non-Compliance #1).

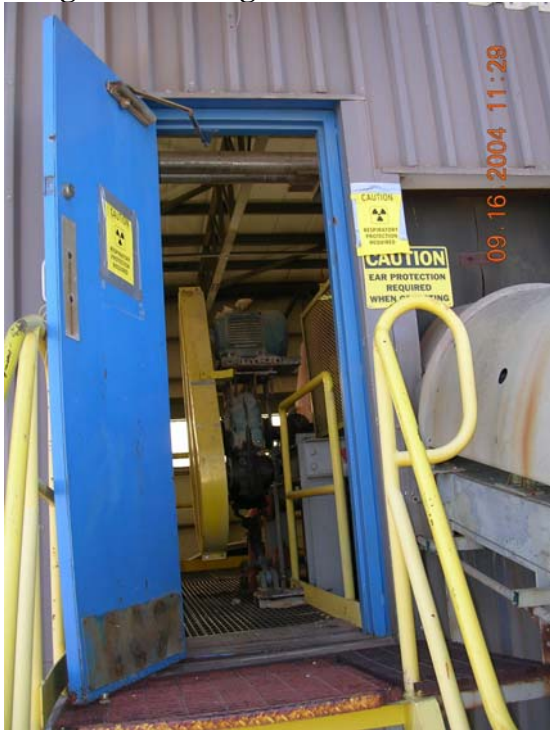
Similarly, radiological postings located near the north conveyor entrance of the building previously used for CaF processing, showed postings of “respiratory protection required” and the trefoil symbol (Refer to Image 2.1 and Image 2.2 of Attachment 1). Areas where respiratory protection is required must be posted as an “airborne radioactivity area” in accordance with RH 4.28.4.

Image 2.1 Postings not in accordance with RH 4.28.4 (Refer to Item of Non-compliance #1).

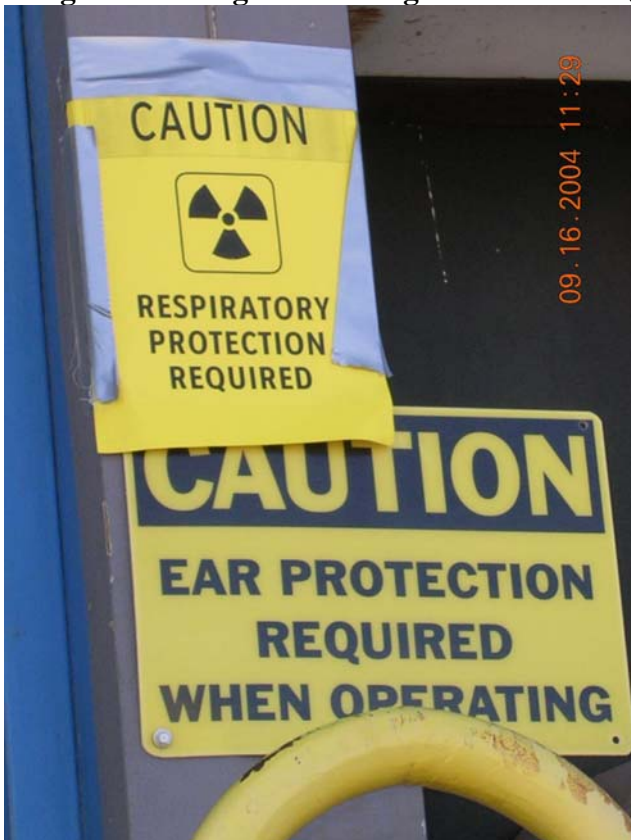
Image 2.2 Enlargement of Figure 2.1 above. (Refer to Item of Non-compliance #1).

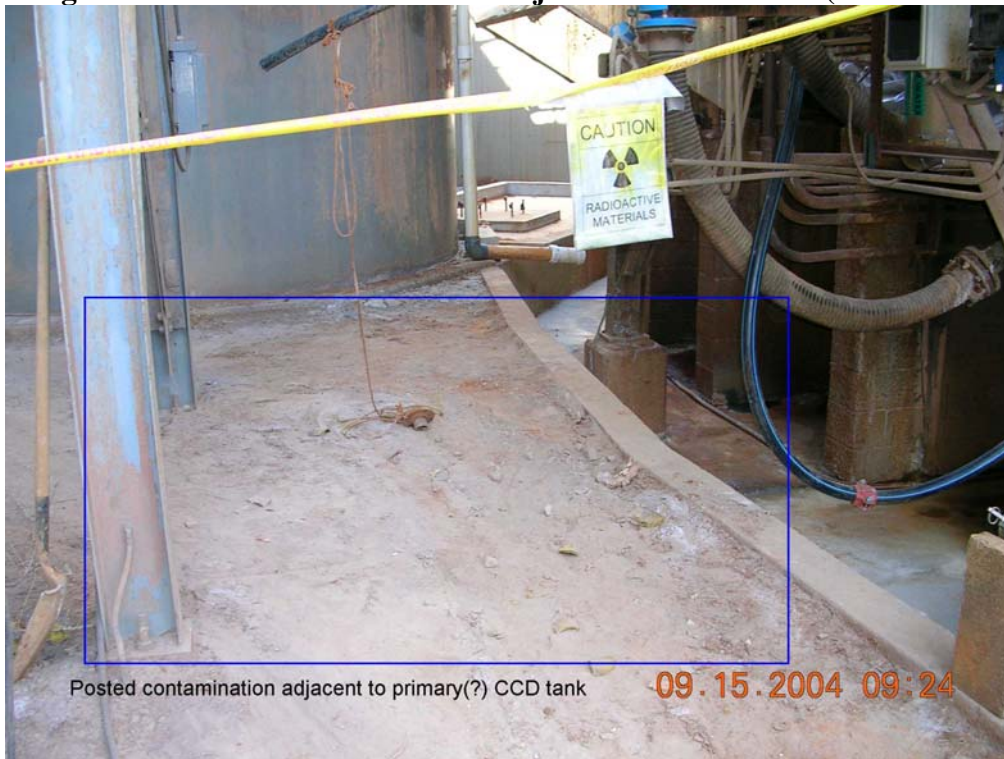
1. An area between one CCD tank and a building has been posted as contaminated for an extended period but has not been cleaned up. Discussions with personnel indicated that the contamination and radiological posting in this area has existed for an extended period. Prompt cleanup or covering of spilled radioactive materials is necessary to minimize the potential for personnel contamination, and additional spread of contamination due to environmental conditions (Refer to Image 3 of Attachment 1).

Image 3. Posted contaminated area adjacent to CCD tank. (Refer to Item of Concern #1).

Posted contamination adjacent to primary(?) CCD tank

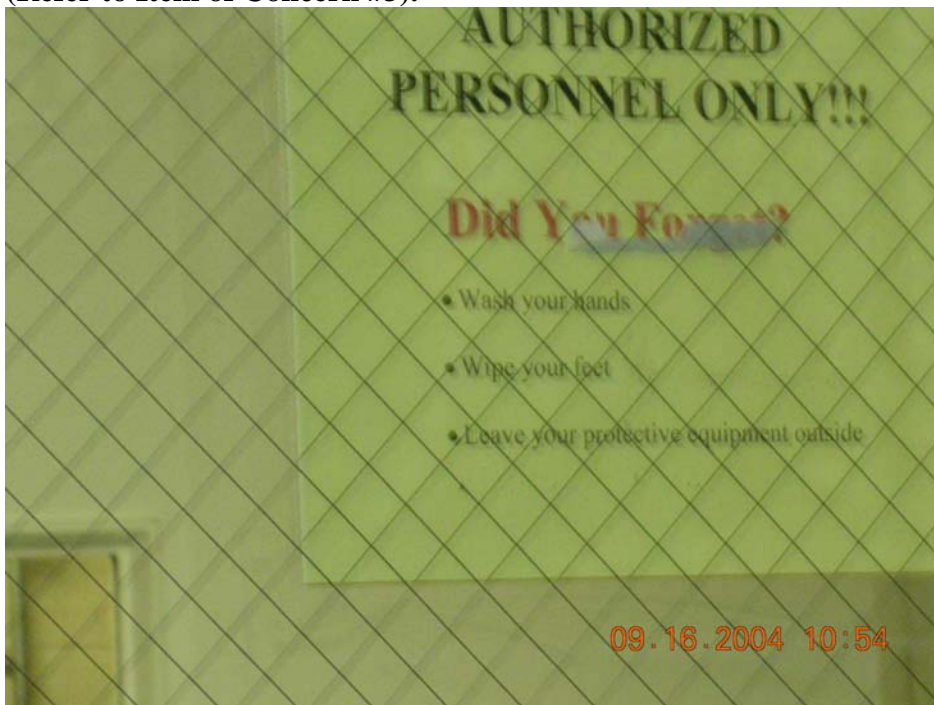
3. Signs and postings used to communicate requirements and information to mill personnel are sometimes vague as to whether they are a requirement or not, or signs are faded, too small to read, or are unclear. Unclear postings may lead personnel, contractors, or visitors into not complying with the requirements resulting in possible contamination spread or present a possible danger to personnel. Efforts must be made to improve all postings to clearly indicate the required actions and information (Refer to Image 4 of Attachment 1).

Image 4. Example of vague informational posting on door to control room. (Refer to Item of Concern #3).

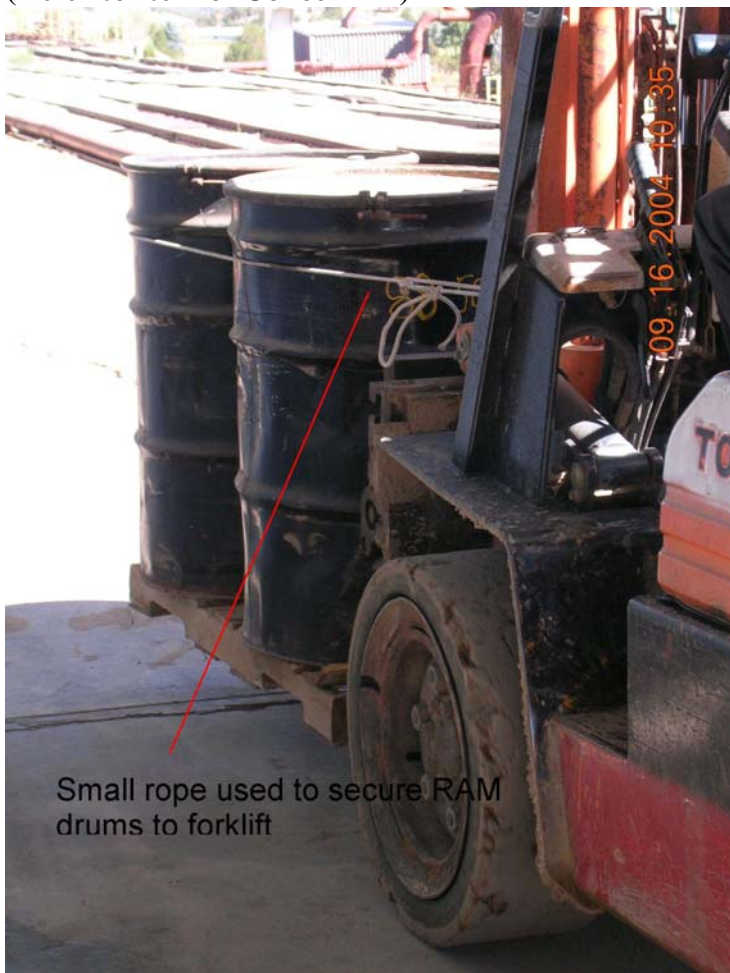
4. During the inspection, movement and relocation of drums from the product storage building was observed. Four (4) drums located on pallets were moved by forklift with the drums secured to the forklift with only a small, inadequate rope. Industrial safety requirements would indicate that movement of four 55 gallon drums weighing in excess of 900 lbs. each require more secure transport. Inadequate securing of drums during transport may result in personnel injury, loss or damage to the drums, and possible personnel, equipment, and site radiological contamination (Refer to Image 5 of Attachment 1).

**Image 5. Inadequate securing and movement of drums containing radioactive material.
(Refer to Item of Concern #4)**

Small rope used to secure RAM drums to forklift
