Re: Cotter Corporation, Canon City Milling Facility RML 369-01
Notice of Violation and Response Request issued by CDPHE December 1, 2004

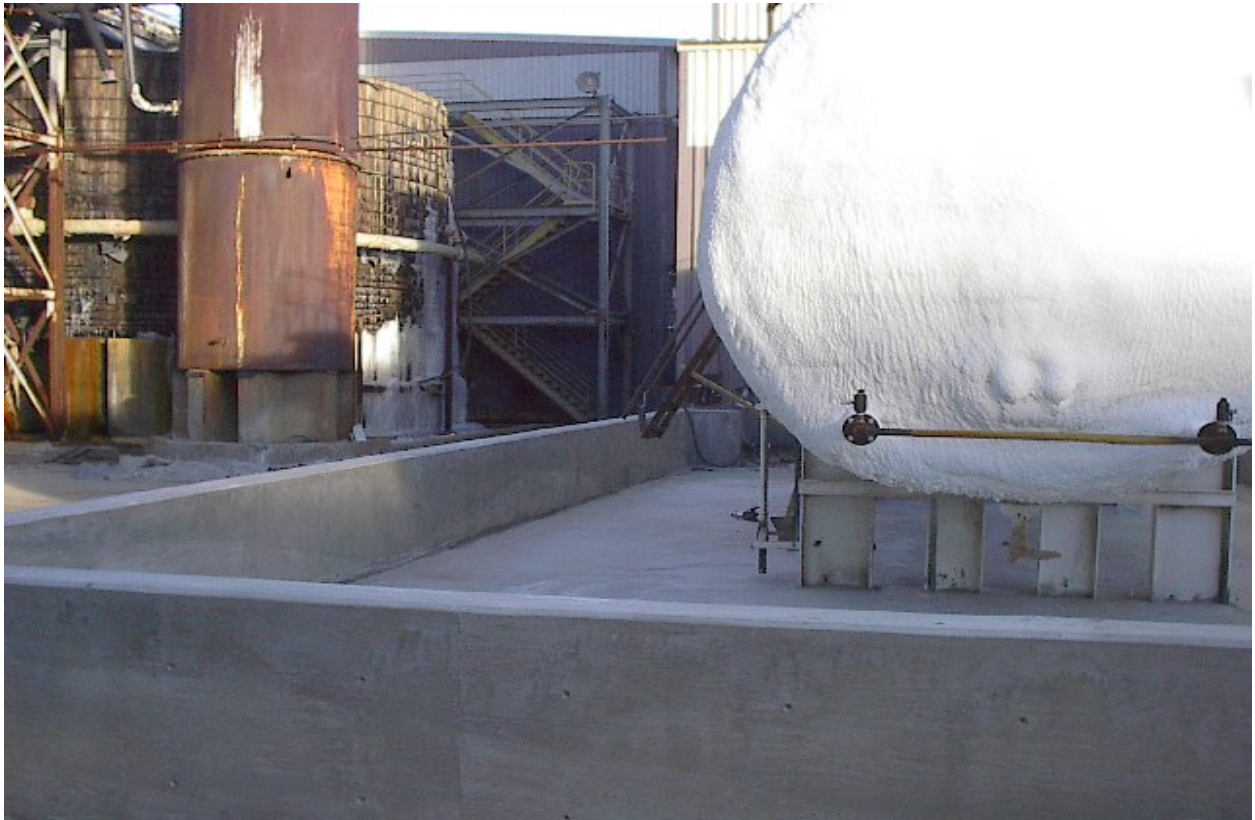
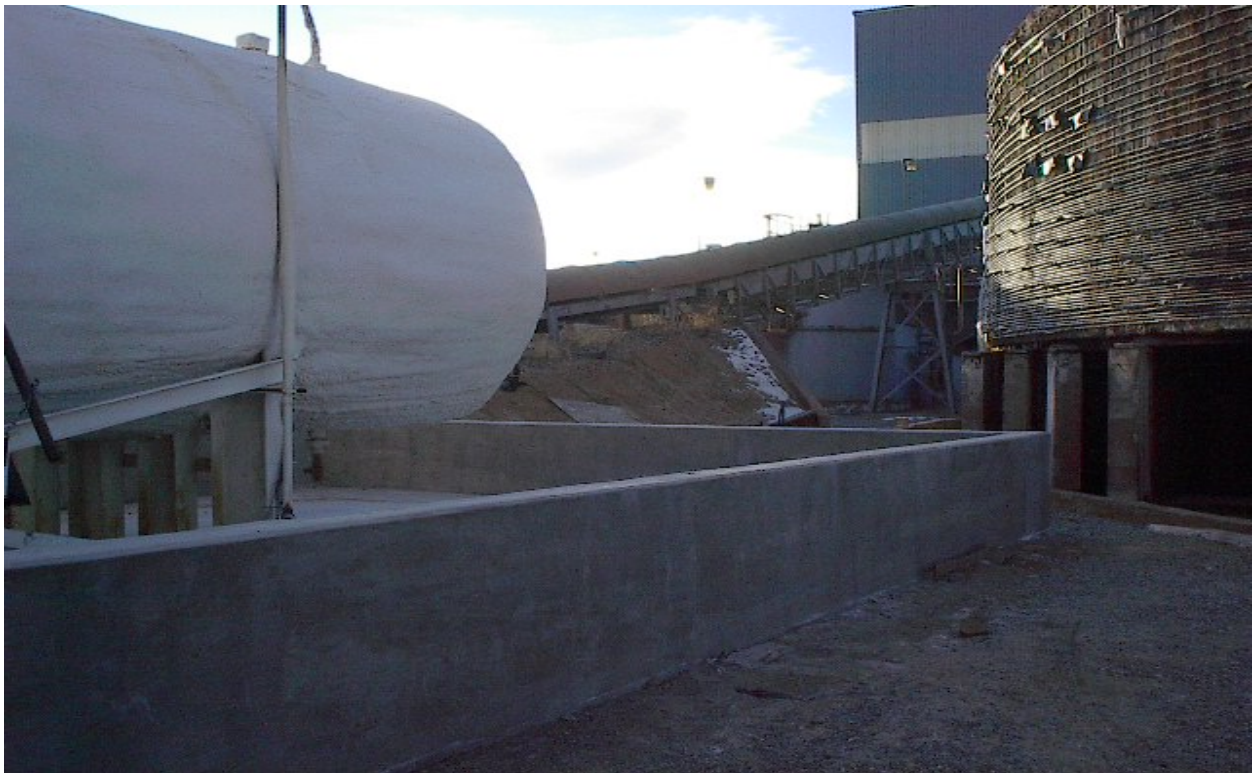
To prevent future releases of sodium hydroxide from the storage tank, it was determined that the original containment structure surrounding the sodium hydroxide tank needed to be improved. To that end, Cotter has since engineered, designed, and constructed a more protective containment as a follow-up to the incident that will ensure control of potential future releases. Specifically, a concrete floor and retaining wall were constructed in the immediate area around the sodium hydroxide tank to provide appropriate secondary containment in the event of a spill or release of chemical from the storage tank.

Construction of the containment system commenced on October 1, 2004 and was completed on October 18, 2004. This newly constructed secondary containment structure provides containment equivalent to 110+% of the volumetric capacity of the sodium hydroxide tank. The containment structure is also fitted with a floor sump pump to accommodate rainfall accumulation and wash down requirements. Pictures of the containment structure are attached.
