TECHNICAL MEMORANDUM

To: John Hamrick, Jim Cain, Cotter Corporation
From: Errol Lawrence, Hydrosolutions
Date: July 30, 2009
Subject: Quarterly Update of Corrective Action Plan for Groundwater North and West of the Canon City Milling Facility

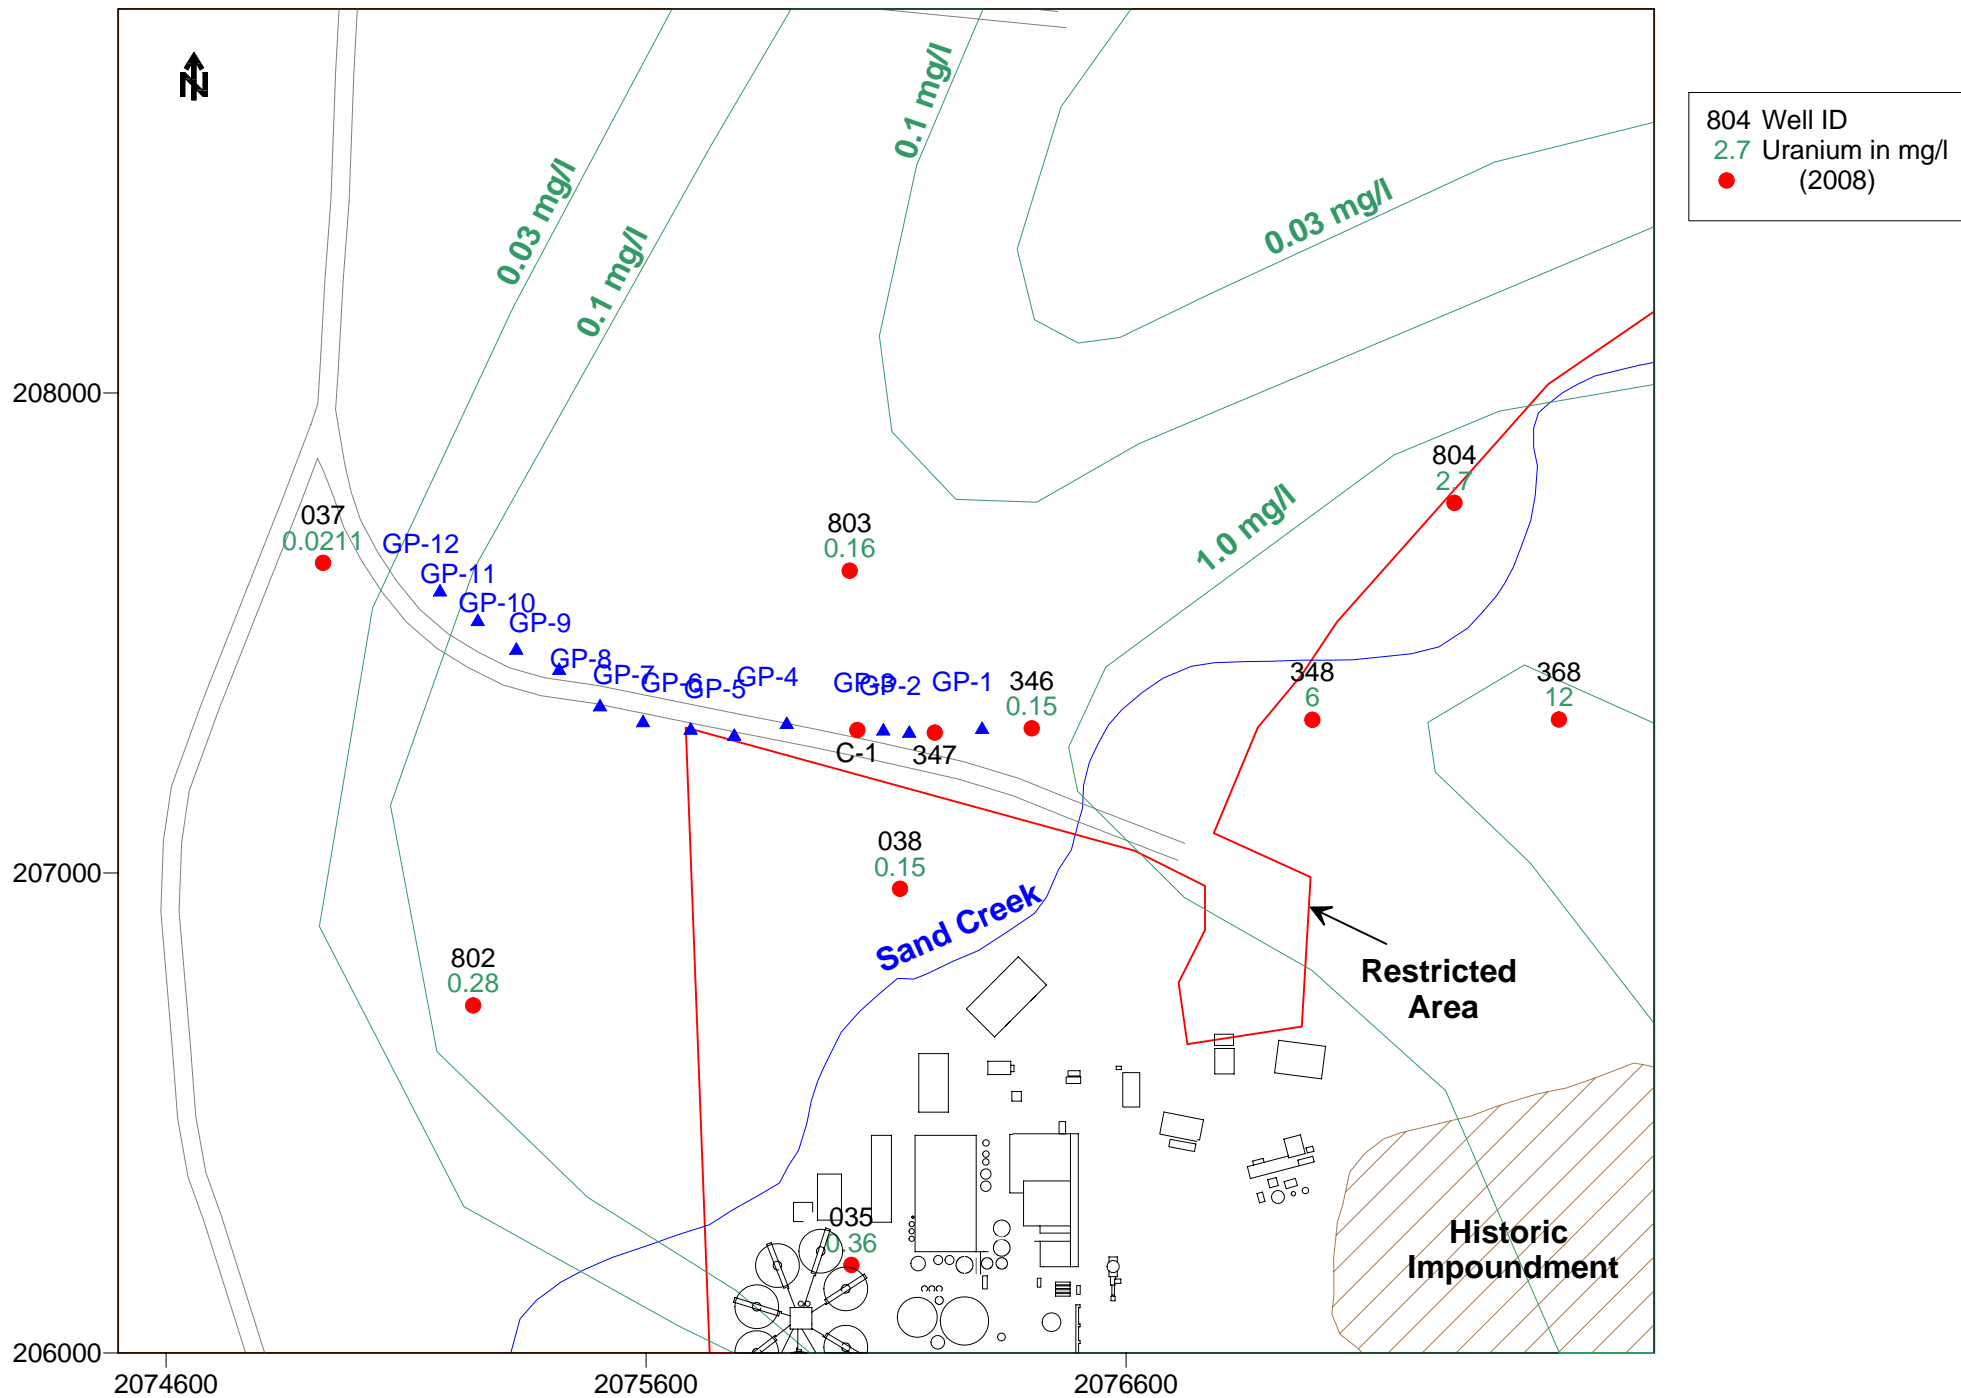
**Figure 1. Geoprobe Locations-CAP Investigation
 Canon City Milling Facility, Colorado, Cotter Corporation**

A total of twelve borings were probed along the northwest property boundary, identified as GP-1 through GP-12 (Figure 1). The borings extended from 100 feet west of monitor well 346 to approximately 250 feet east of monitor well MW037. One additional boring was probed near the West SCS dam (GP-13). Each boring was advanced until refusal of the direct push method. Two borings, GP-2 and GP-10 were augered beyond the direct push refusal point to total depths of 49 and 52.5 feet below ground surface (ft bgs), respectively. The depth of refusal ranged from 9.0 to 38.6 ft bgs. The alluvial materials consisted primarily of silty clay, silty sand and gravelly sand. The bedrock materials consisted primarily of sandy clay to claystone and cobbly sandstone. Table 1 provides the description of the cores from surface to total depth for each boring.

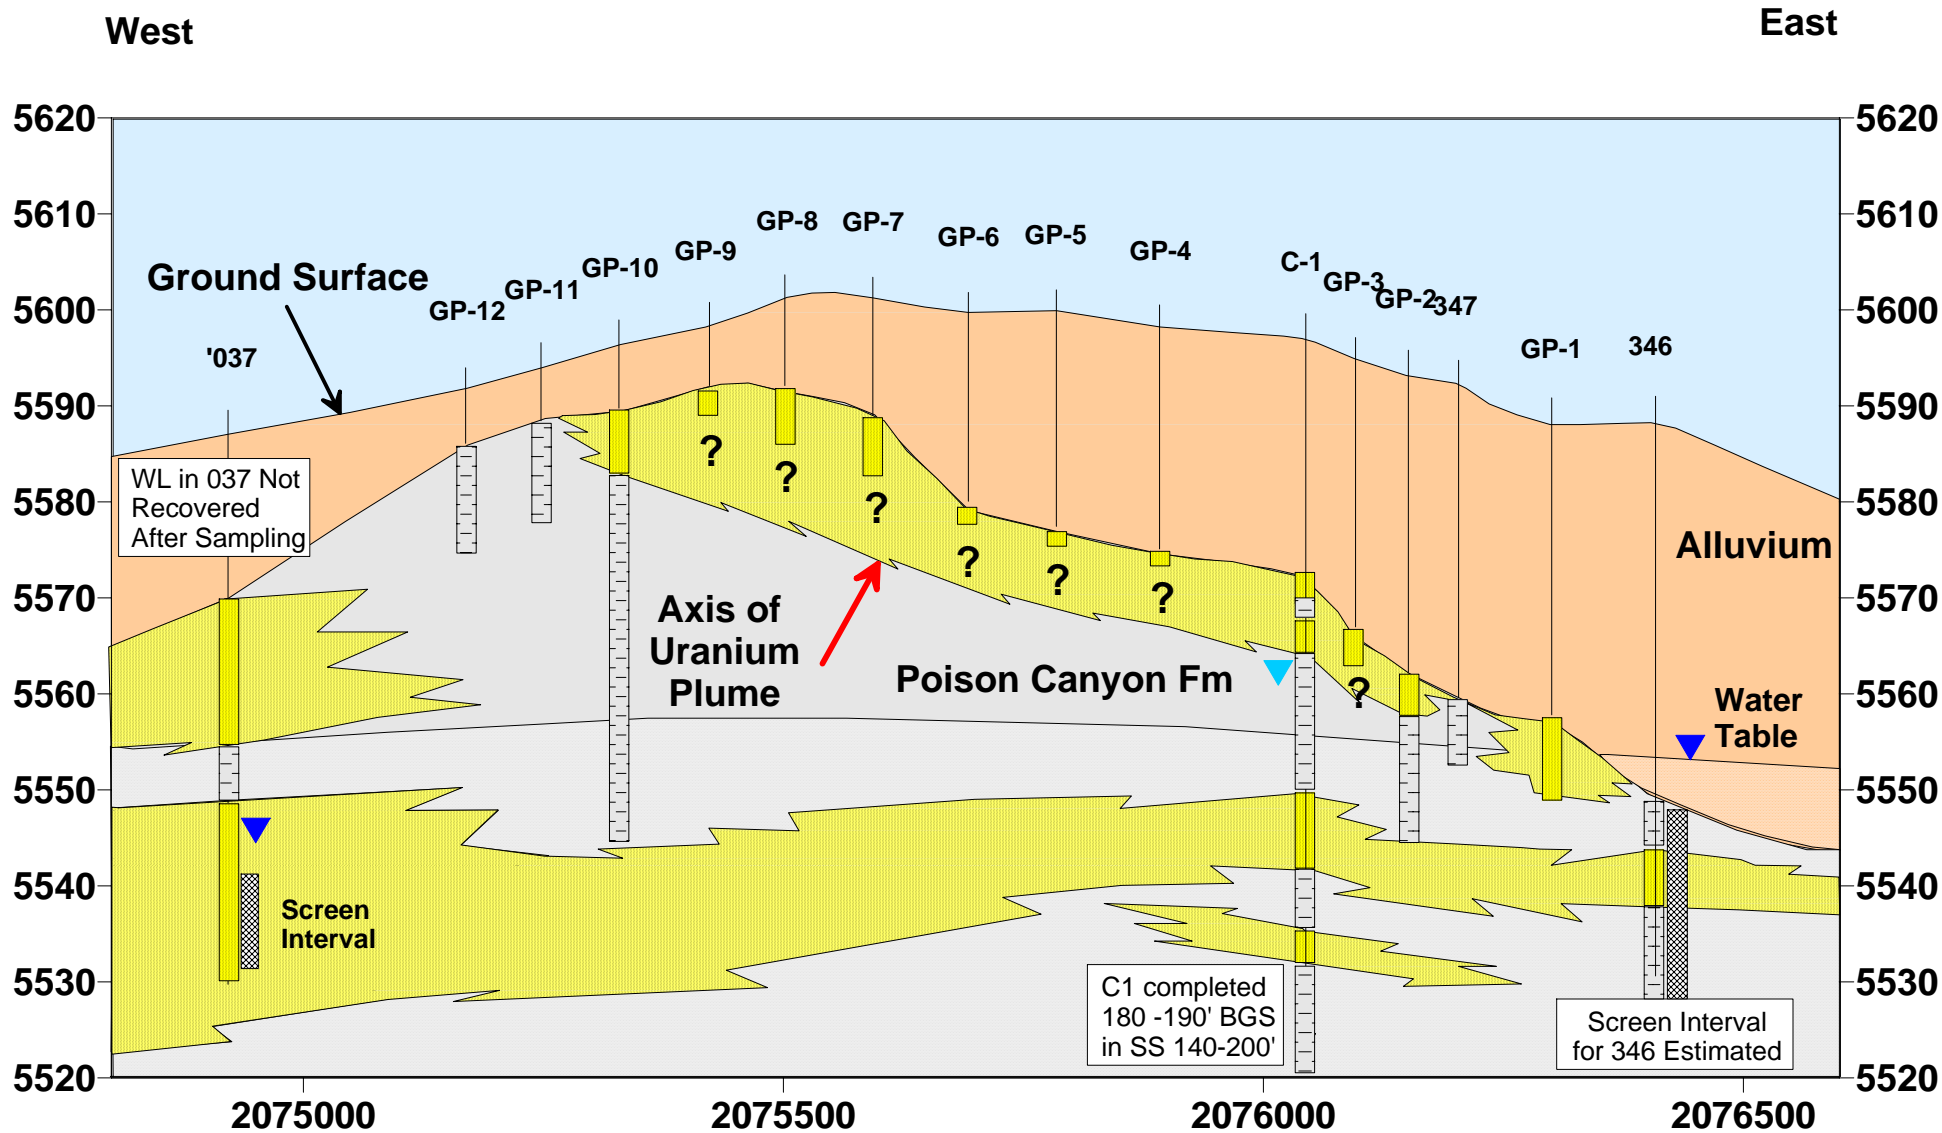
Figure 2. Cross Section Interpretation of Geoprobe Survey Northwest Property Boundary, Canon City Milling Facility, Colorado, Cotter Corporation

Results of the lithologic interpretation of the cores are plotted on cross sections. Two interpretations of the data are presented. In Figure 2, the sandstone identified in existing wells MW037 and 346 (as well as historic boring C-1) that is below the water table, is assumed to be connected. For that to be true, the sandstone must be deeper than the total depth penetrated at boring GP-10. Cuttings from GP-10 were clearly clay to claystone for the last 30 feet of penetration (to total depth of 52.5 ft bgs). Figure 3 present an alternate interpretation whereby the sandstone in MW037 and 346 pinchout and are discontinuous. This interpretation might explain why water quality at MW037 does not showed elevated uranium concentrations.

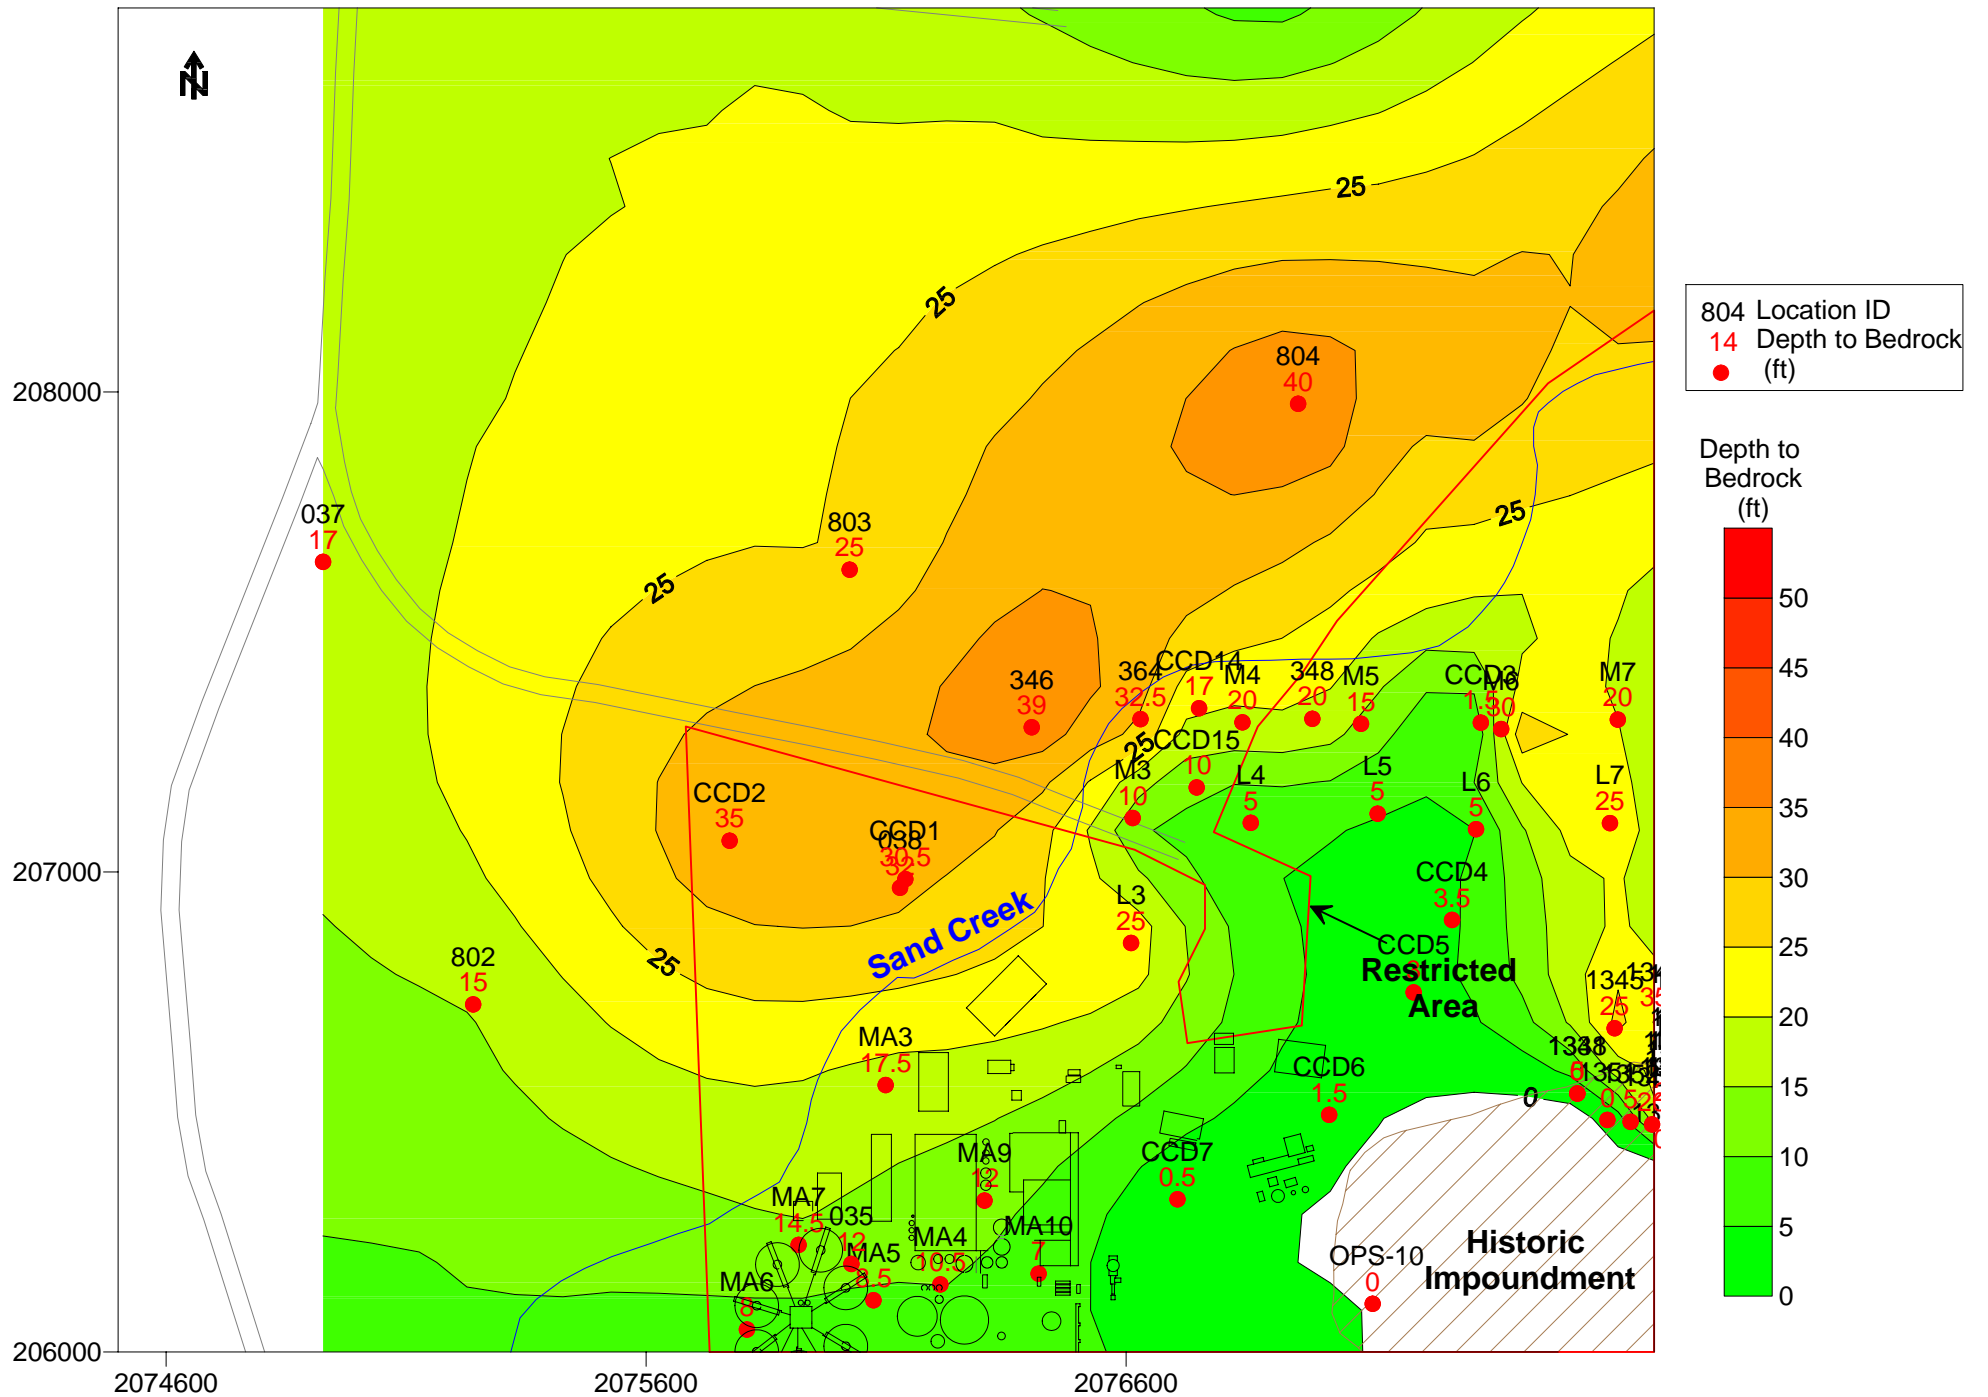
Figure 4. Pre-Geoprobe Survey - Depth to Bedrock Map
Canon City Milling Facility, Colorado, Cotter Corporation

The shallow occurrence of bedrock west of 346 resulted in a change in the bedrock surface map. Figure 4 represents the bedrock surface map prior to the geoprobe survey. The revised bedrock surface map, indicating the bedrock high west of well 346 and near well MW037, is shown on Figure 5.
