**The NRC and  
Nuclear Power  
Plant Safety  
in 2010:  
A Brighter  
Spotlight Needed**

DAVID LOCHBAUM

**Union of Concerned Scientists**  
*March 2011*

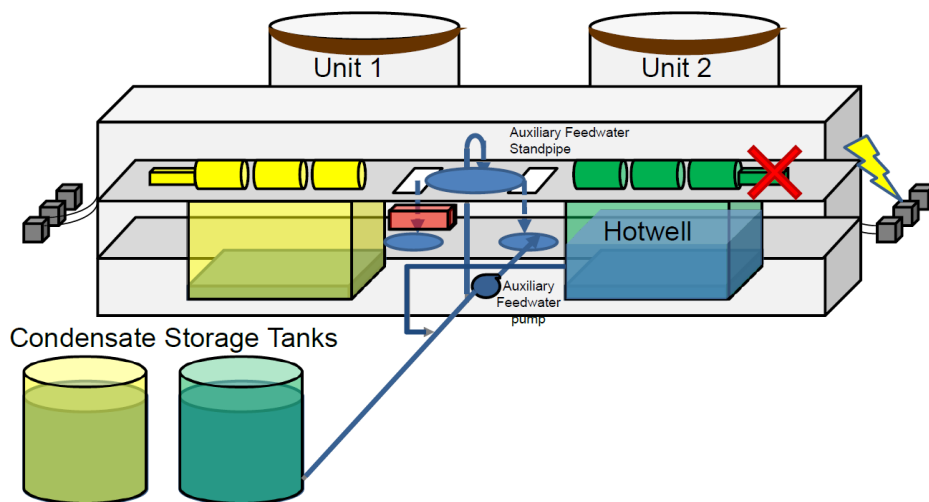
*NRC drawing of the key components involved in the Braidwood near-miss. The red "X" indicates where the event started, when the main generator shut down.*

However, the flow-control valve for one AFW pump failed in the open position, and the water level in the main condenser hotwell rose until valves opened to send some of this water back to the condensate tank. Nearly 12,000 gallons of water spilled onto the floor of the turbine building, from open standpipes installed on the piping between the outdoor tank and the AFW pumps (NRC 2010j).

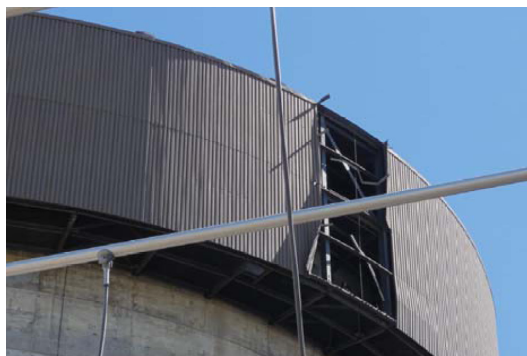
After the Unit 1 reactor shut down, the main steam safety valves (MSSVs) automatically opened to relieve pressure in the piping carrying steam from the steam generators to the main turbine. One MSSV stuck open after pressure dropped back below the opening set points. The operators did not realize that the MSSV was open until a worker arriving at the site 40 minutes later told them. Meanwhile steam passing through this open valve dislodged sheet-metal siding around the top of the Unit 1 containment building. Some of the siding landed on power lines for the Unit 1 off-site power transformer.

*NRC photo of the metal siding torn from the containment building at the Braidwood nuclear power plant in Illinois.*

The second violation involved failure to properly evaluate operating experience. Workers had evaluated an event at another nuclear plant where steam had dislodged metal siding, and had concluded that it did not apply to Braidwood. They failed to evaluate a previous event at Braidwood in which steam had dislodged metal siding. The NRC classified both violations as Green—the least serious of the color-coded violations.

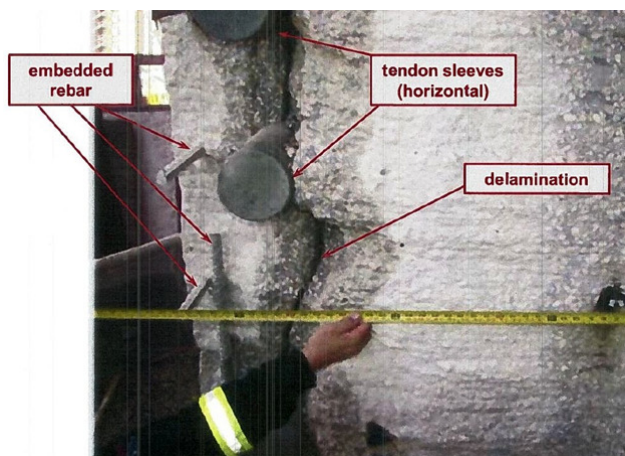
*NRC picture of the crack (delamination) in the concrete containment wall at Crystal River 3 caused when workers cut a square opening to replace the steam generators.*

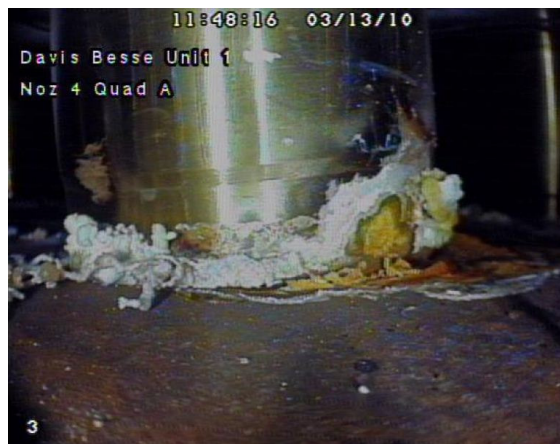
*White-crystalline boric acid leaked through a cracked nozzle in the head of the reactor vessel at the Davis-Besse plant in Ohio. NRC photo.*

However, inspections during the March 2010 refueling outage revealed that two cracked CRDM nozzles had leaked borated reactor cooling water, and that many other nozzles had apparent cracks. Although the reactor vessel head did not need repair or replacement, workers repaired 24 of the 69 CRDM nozzles.

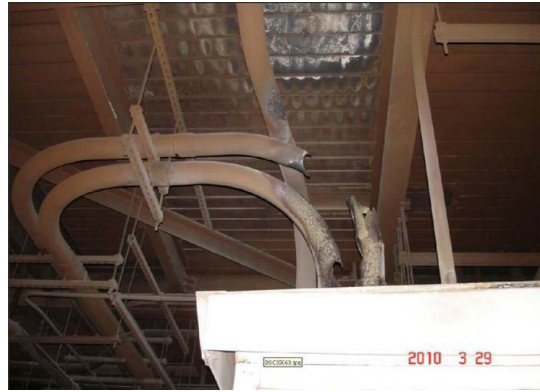
About four hours into the event, the operators attempted to restore power to the de-energized circuit, but they did not check first to ensure that workers had fixed the original fault—and they had not. When the operators closed the electrical breaker to repower the circuit, they reenergized the shorted cable, and it caused another fire. The electrical disturbance also triggered alarms on

*Conduit for electrical cables damaged by the fire at the HB Robinson plant. NRC photo.*

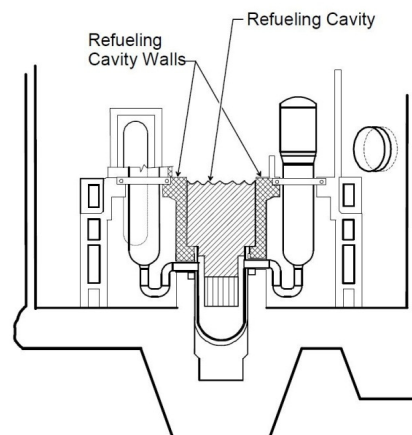
However, NRC inspectors at Indian Point recently found that the liner has been leaking 2 to 20 gallons per minute since at least 1993 (NRC 2010v), and that the plant owner has not yet delivered on repeated promises to fix the leak. That means the device installed to prevent leakage after an earthquake is leaking before an earthquake even occurs. The liner has no other safety function. Yet NRC managers have dismissed the longstanding problem, noting that the refueling cavity leaks only when it is filled with water (NRC 2010o).

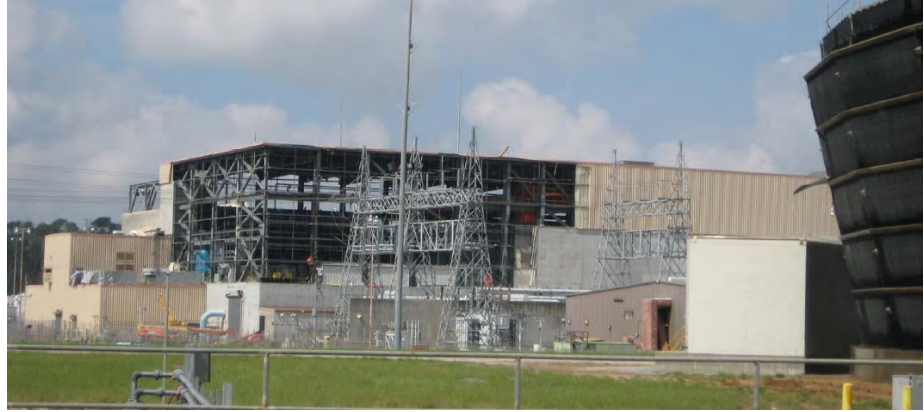
In September 2008, Hurricane Gustav caused considerable damage to the River Bend nuclear plant outside Baton Rouge, La. High winds tore sheet metal siding from three sides of the turbine building. The company repaired some damage and prepared to restart the reactor—planning to replace the walls of the turbine building later.

*The turbine building at the River Bend plant after Hurricane Gustav removed its metal siding. NRC photo.*
